# **Incident Analysis Report: B696 MOVER Event, August 19, 2004**

**Report Serial Number: 0514  
April 27, 2005, Rev. 2**

Lawrence  
Livermore  
National  
Laboratory

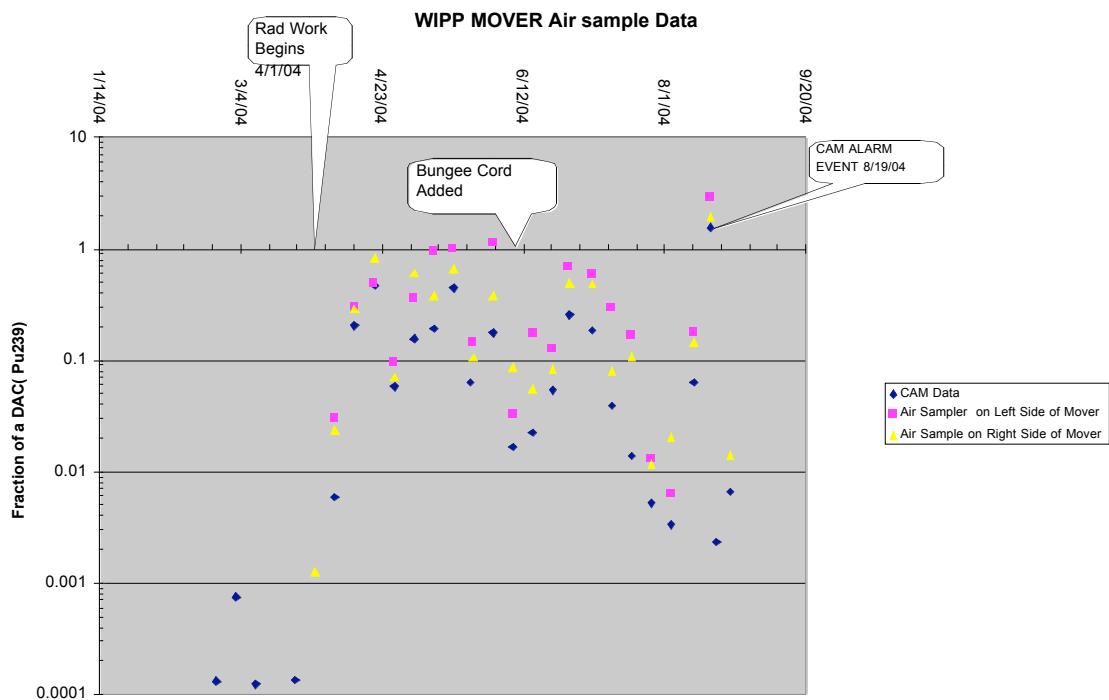
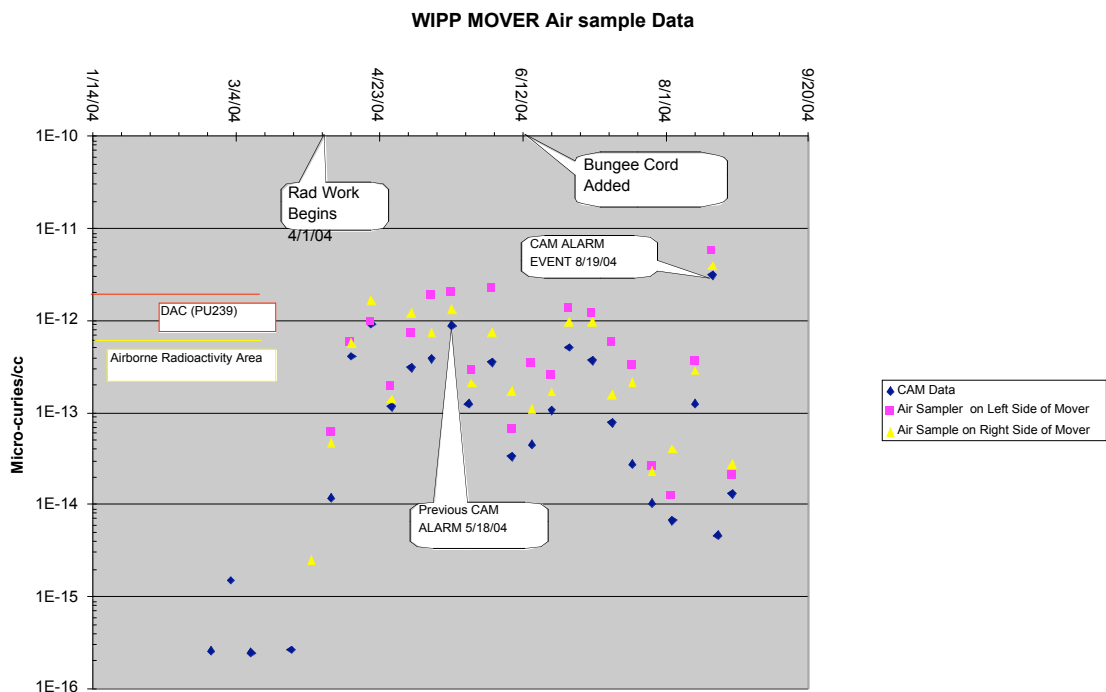
Figure 5. Air sample data show a chronic airborne radioactivity condition present in the MOVER from April 1, 2004, through August 19, 2004.

Most of the positive airborne radioactivity samples were less than the activity level that would have caused the CAM to alarm, and many were below the notification level employed by the Radiation Measurements Laboratory (RML) of  $10^{-13}$   $\mu\text{Ci/ml}$ . As a precaution, the HP placed MOVER workers on a monthly bioassay program versus the standard semi-annual sampling program. Radioactive contamination control swipes indicated that very little contamination was spread during the entire period of MOVER operation.

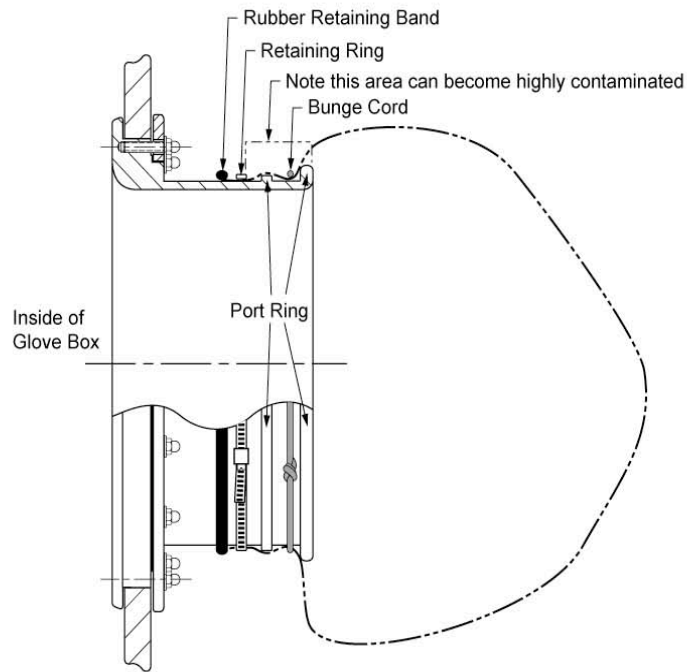
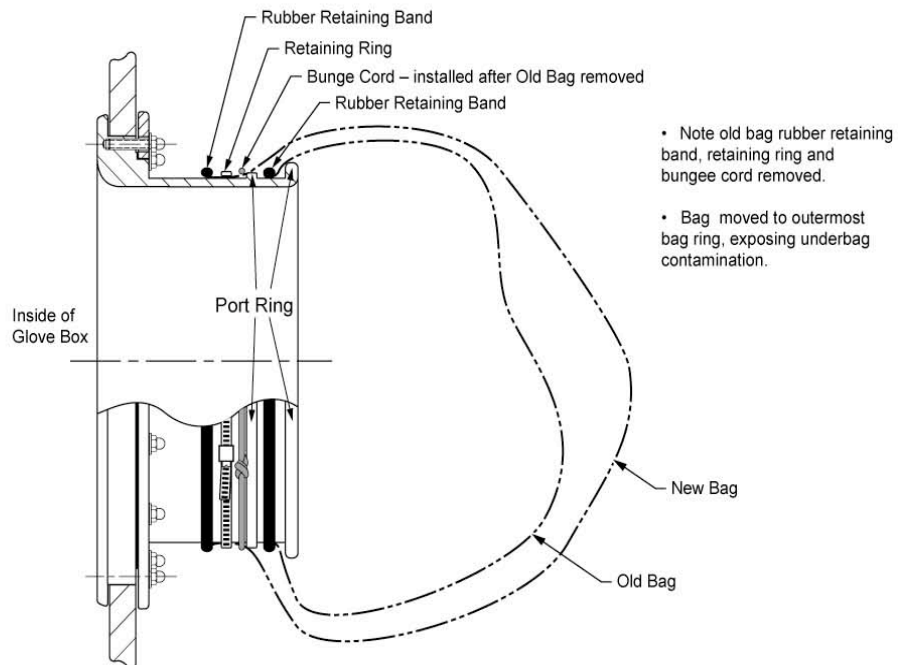
Figure 6. MOVER working configuration (top) and bag-change configuration (bottom).

During the August 19, 2004, event, MOVER operators observed that the retaining band was not tightened adequately. CCP personnel attributed the problem to a worn clamp-tightening screw, and the clamp was subsequently replaced. The IA Committee believes that the clamp mechanism was never completely effective even in its normal state, and its degraded condition would have allowed more contamination to make its way through the retaining clamp to the area up to the rubber retaining ring. A third mechanism for providing a contamination seal (installed in June as suggested by LLNL ES&H personnel) was a bungee cord installed around the bag on the outboard side of the hose clamp to attempt to seal the drum bag to the bag port. The bungee cord had several knots, and the end hooks were still attached. The presence of knots and hooks, and the absence of pressure adjacent to them, provided for channels that contamination could pass through. Although the bungee cord may have had some effect on reducing contamination on the glovebox bag port, it was not totally effective as a seal.

Thus, the three sealing methods discussed above each provided a tortuous pathway for material to enter the air in the MOVER. As a result, a small amount of material could easily escape through the three compression seals because each had a leak path to the next seal, and eventually through the bag port interface.

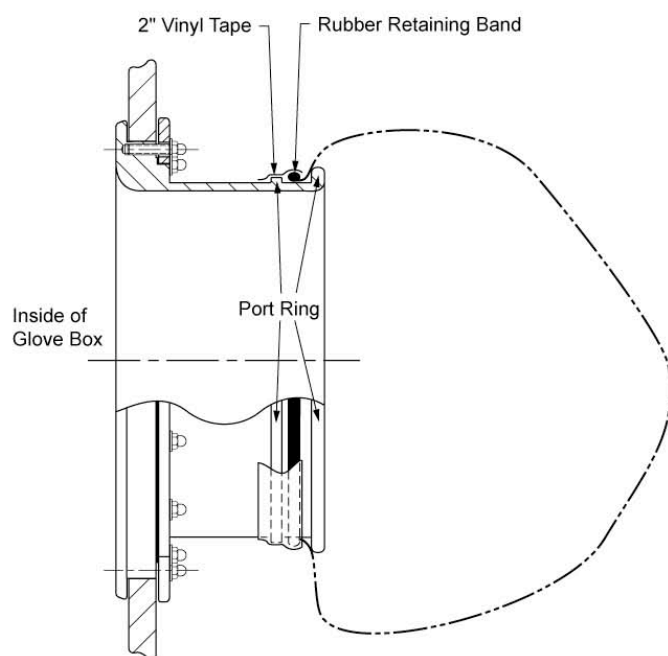
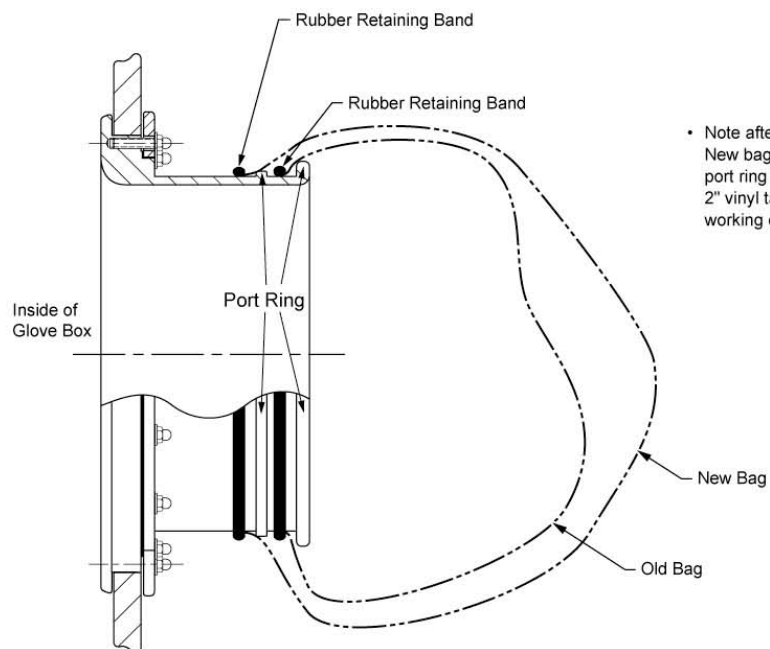
Figure 7. LLNL Plutonium Facility working configuration (top) and bag-change configuration (bottom).

- Note bag is positioned in outermost port ring to minimize contamination.

- Note after old Bag is removed, New bag is moved to outermost port ring and taped in place with 2" vinyl tape as pictured in working condition.

Whereas the CCP design used two contamination rings to provide a seal, neither was effective. HP 1 and the HP SME identified the potential for leakage at the bag/bag-port interface. Their recommendation for an additional bag seal (bungee cord) was also ineffective in correcting this leak path. A positive seal of bag to the bag port is needed. A demonstrated and effective way to accomplish such a critical seal is to use 2-in.-wide vinyl tape overlapping the bag to the port.

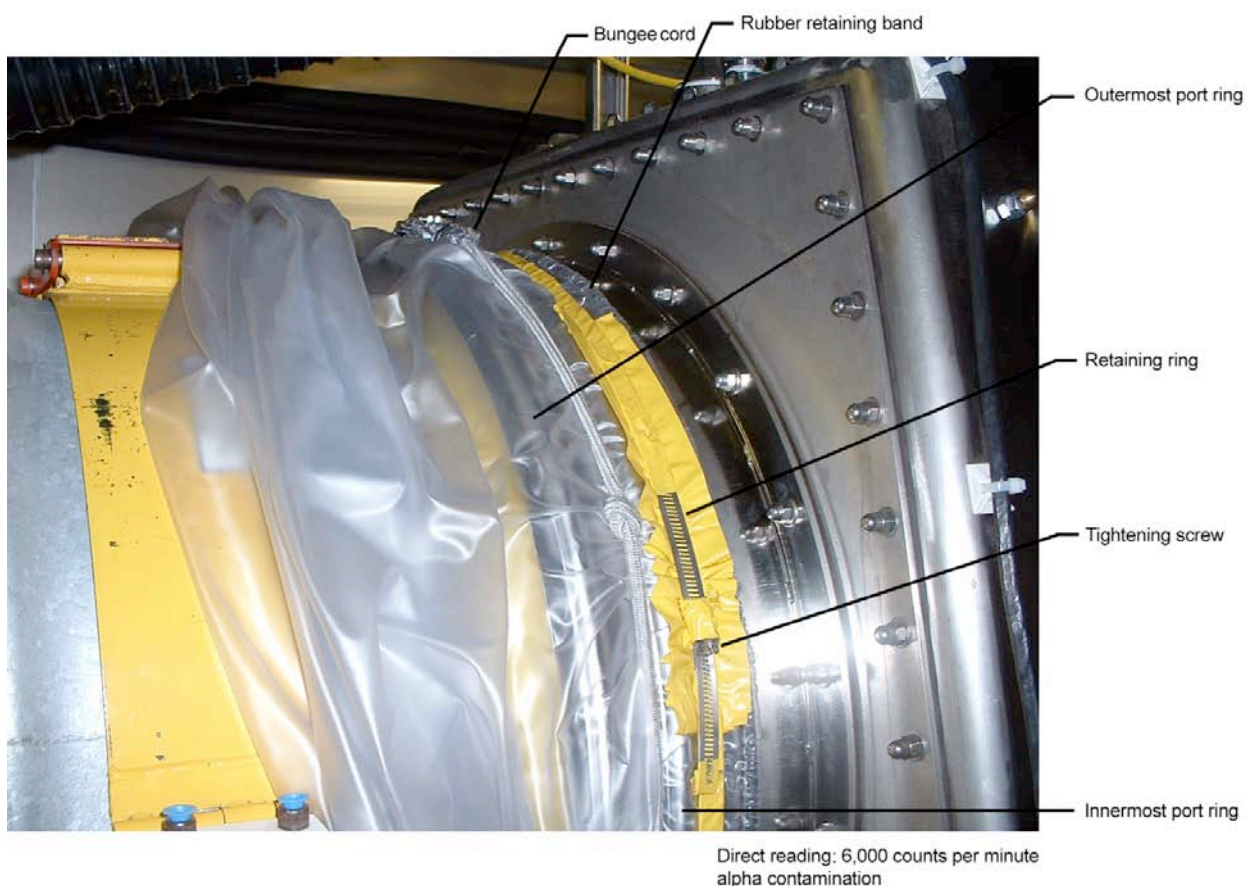
Figure 8. Photo of MOVER configuration, August 19, 2004, showing bungee cord, rubber retaining band, retaining ring, and tightening screw.
